Manhole Inspection Summary

Manhole # S21A__018MH

Insp Date: **10/18/07 1:14 PM**

Location Address: **634 MONROE-FULTON**

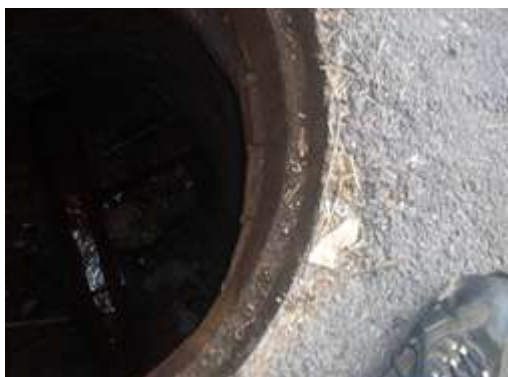
Defect 1

Frame Offset: **0.5** (in.) Condition: ☒ Sound ☐ Cracked ☐ Leaks

.5 FRAME OFFSET

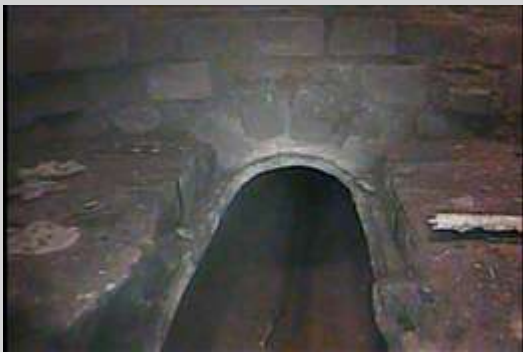
12 O'Clock Outflow

8 in. Circular Gravity Sewer
Pipe Out @ 12 O'Clock

Pipe Height: **7.2** (in.) Rod and Bar (Angled)
Pipe Material: **Clay** ☐ Pipe Lined
Invert Depth: **8.76** (ft.) Flow Characteristics: **Slow**
Deposits: ☒ None ☐ Mud ☐ Sludge ☐ Debris ☐ Grease
Silt Depth: (in.) Deposits Extent:
Infiltration: **None** Pipe Seal Cond: **Sound**

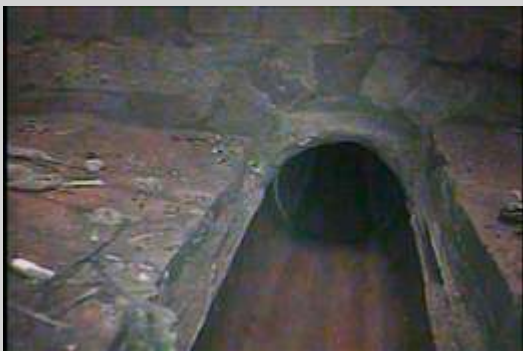
6 O'Clock Inflow

8 in. Circular Gravity Sewer
Pipe In @ 6 O'Clock

Pipe Height: **8.4** (in.) Rod and Bar (Angled)
Pipe Material: **Clay** ☐ Pipe Lined
Invert Depth: **8.71** (ft.) Flow Characteristics: **Slow**
Deposits: ☒ None ☐ Mud ☐ Sludge ☐ Debris ☐ Grease
Silt Depth: (in.) Deposits Extent:
Infiltration: **None** Pipe Seal Cond: **Sound**

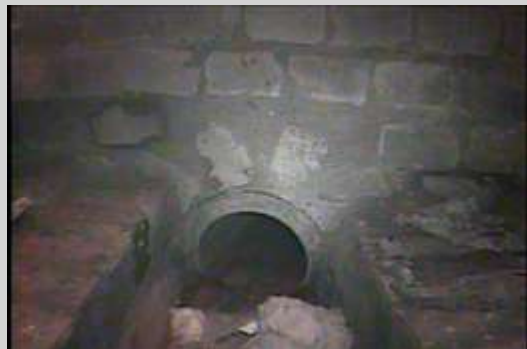
9 O'Clock Inflow

6 in. Circular Gravity Sewer
Pipe In @ 9 O'Clock

Infiltration: **None**

Pipe Seal Cond: **Sound**
